# Newcastle Ocean Baths Stage 2: Coastal inundation assessment

| <b>Reference</b> | P23346_NOBStage2Inundation_R3.00 |
| <b>Subject</b> | Inundation assessment of Newcastle Ocean Baths Stage 2 Design |

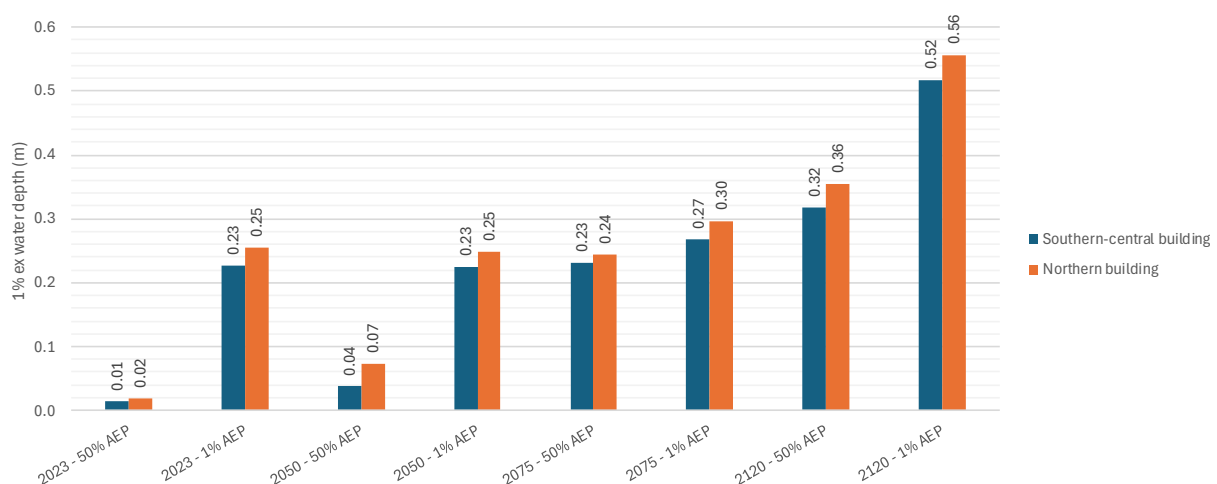
Figure 2 presents the characteristic 1% exceeded inundation depths at the southern-central and northern pavilions. There is limited difference between the two locations for the present-day and 2050 1% AEP scenarios, with characteristic depths of approximately 0.23 to 0.25 m.

A 2075 sea-level-rise scenario of approximately 0.41 m was derived from the modelling results to represent the 1% AEP condition over an indicative 50-year design life. Under this planning horizon, the characteristic 1% exceeded inundation depths are approximately 0.27 m at the southern-central pavilion and 0.30 m at the northern pavilion.

**Figure 2: Characteristic 1% exceeded inundation depths at the seaward face of the pavilion buildings.**

These depths provide the design basis for doors, gates, glazing, temporary barriers, internal drainage, water-resistant finishes and protection of electrical and service infrastructure. The reduced exposure of the pavilion interiors is primarily attributable to the increased finished floor level and the arrangement of the pool edge, pavilion deck and surrounding public-domain levels represented in the numerical model.

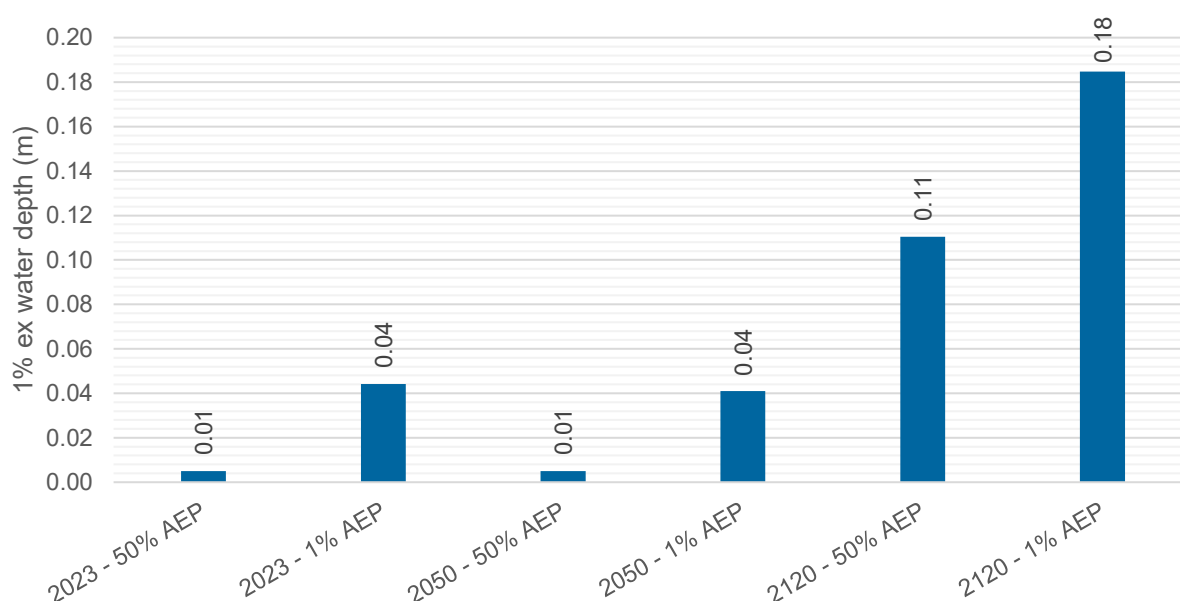
The main switchboard (MSB) is located on the landward side of the carpark near the opening between the northern and central buildings. The MSB sits on a concrete plinth approximately 0.3 m above ground level. Sensitivity testing undertaken in Stage 1 was used to determine 1 % exceedance water levels at

this location, as the inclusion of the modelled buildings is essential to capture accurate inundation behaviour. As such, the results from the Stage 1 modelling were used to derive these inundation depths. The results (Figure 3) indicate that even under the 2120 planning horizon, inundation depths remain below the base of the MSB enclosure. However, vertical splashing and local run-up may still occur during extreme events, and the MSB housing should therefore be constructed to an appropriate weathertight standard.

**Figure 3: Inundation depths at the Bath's main switch board.**

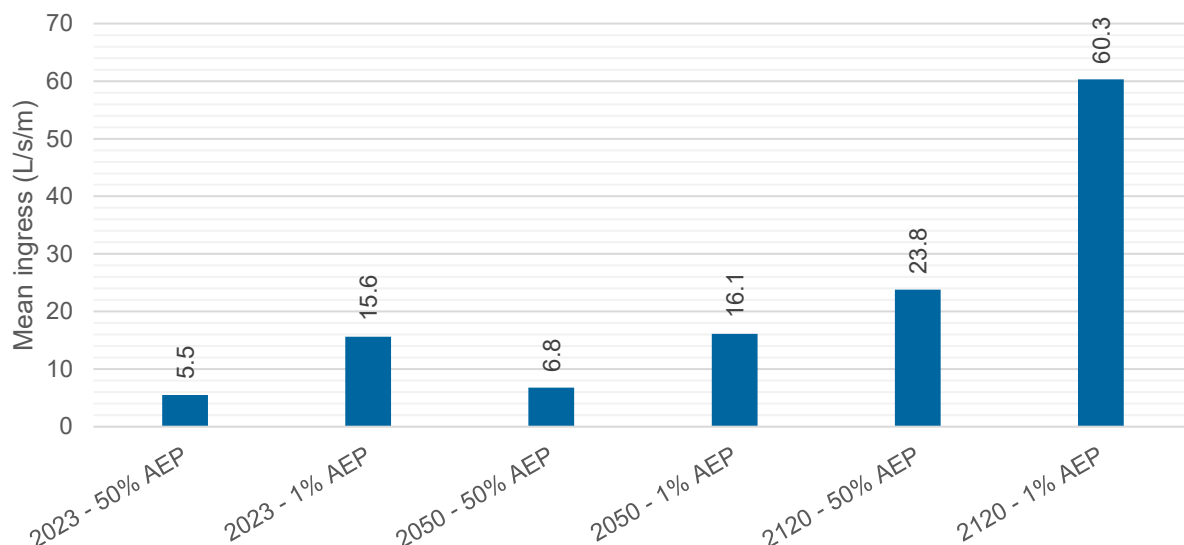
The northern pavilion contains a principal seaward-facing entrance to the male and female amenities. The security gate or grille at this entrance will not prevent water ingress during overtopping events.

Model outputs were used to calculate potential water-ingress rates from the time-varying water depth and flow velocity immediately in front of the entrance. The calculated mean unit ingress rates range from approximately 5.5 L/s/m for the present-day 50% AEP condition to 60.3 L/s/m for the 2120 1% AEP condition. The applicable unit rate should be multiplied by the final clear opening width to establish the design inflow rate.

**Figure 4: Mean water ingress rates (L/s/m) for the northern pavilion change door entrance for modelled scenarios.**

The northern amenities should be treated as wet and semi-open marine spaces. The drainage design should account for inflow through the principal seaward entrance and lower northern end entry, wind-driven rain and salt spray beneath the canopy, distributed floor falls, local ponding behind cubicles, sump and pump capacity and prevention of backflow from external drainage systems.

Internal walls, thresholds and drainage should prevent water entering the amenities from migrating into the central pavilion, communications switch room, plant rooms or other water-sensitive spaces.

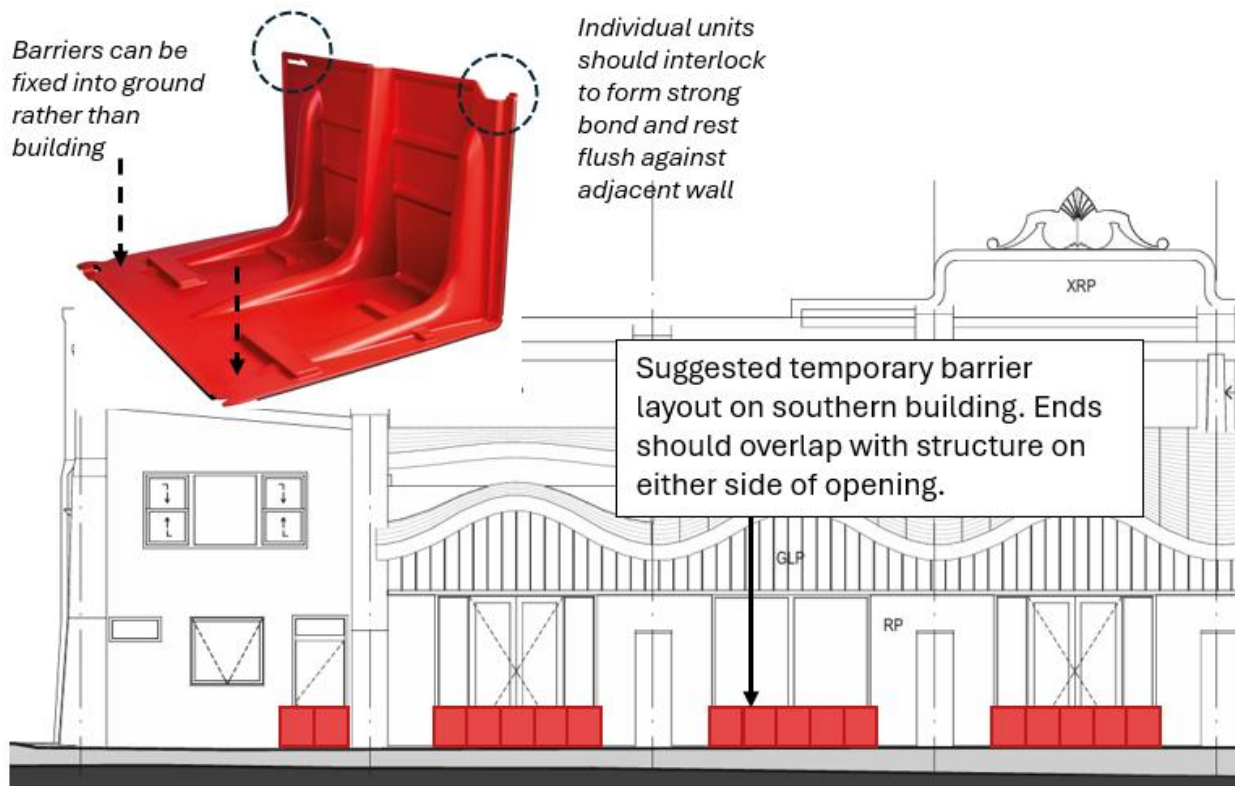
**Figure 5: Possible temporary wave barrier layout on seaward façade of Southern building (indicative only).**

Under the 1 % AEP (2050 + SLR) scenario, the modelled overtopping depth at the pavilion deck is approximately 0.25–0.30 m. Installation of modular barriers would prevent direct ingress through doors and openings for all events up to this design condition. Residual splash and seepage can be managed through internal drainage and sump pumps, providing effective operational protection without the need for permanent structural modification.

Temporary barriers are recommended at vulnerable seaward-facing openings in the southern pavilion and may also be appropriate at the lower northern entry.

The selected system should be designed for the adopted water depths and wave-induced flow conditions. The detailed design should identify the barrier extent and height, restraint and fixing arrangement, storage location, deployment access, inspection requirements and compatibility with accessibility and normal door operation.
